A scanning electron microscopic study on the HA-coating of implant following insertion into the cadaver goat jaw bone

Abstract

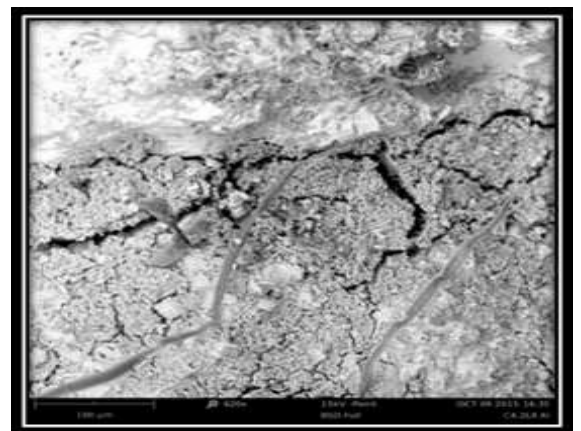
Fig. 5a: The SEM microphotograph of coated dental implant before insertion (x600)

The scanning electron microscopic observation of the unused HA-coated unused implant shows an uneven surface layer of calcium hydroxyapatite with dome shaped elevations and adjacent concavities representing porosities (Fig. 4, 5a, 5b). The inserted implants were harvested by unscrewing. The coated implants surface had suffered an insertion torque force. This was reflected on the surface layer in the form of cracks and loss of HA coating in a sprawling manner. The implant with higher diameter (L10 X D4.2) had suffered significant loss of surface layer in the form of discrete cracks on the coated surfaces at random. It also had lot of soft tissue debris probably entangled over the surface during implant removal. However, the inserted implants should have been removed by fracturing the bone instead of unscrewing. Although the surface damage was also observed on 3.8mm diameter implant but the cracks were inconspicuous compared to 4.2mm diameter implant. The breakage of dome shaped areas were observed on the surface of 3.8mm diameter implant was less compared to 4.2mm of implant. It is postulated that higher diameter implant was required to be inserted with much torque force than with the lesser diameter implant. This can also be interpreted that the higher diameter implant had more implant- bone contact compared to the lesser one. The reasoning for such difference in damage and its pattern on the dental implant surface may vary upon the type of coating and its thickness; and also on the material with which was coated. This has been observed that the types of surrounding hard tissues in the cadaveric goat jaw bone and its characteristic property can alter the surface of coated dental implant. The macro design of dental implant here is described in terms of length and diameter that have been conclusively observed under SEM photomicrograph. The coating used was calcium hydroxyapatite, here denoted as HA coated surface, and was meant for better connections with the surrounding bones. The scanning electron microscopic observation are very clear and conclusively have shown that with

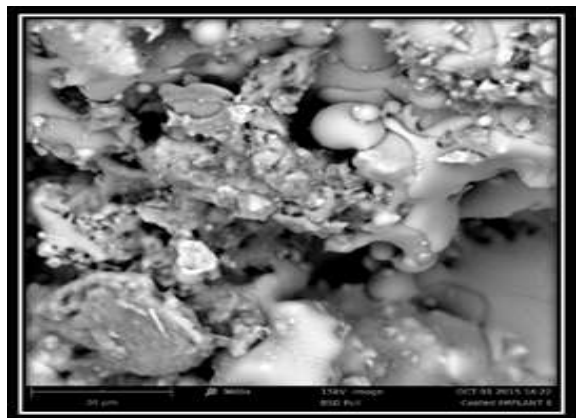
Fig. 5b: The SEM microphotograph of coated dental implant before insertion at higher magnification(x3600)

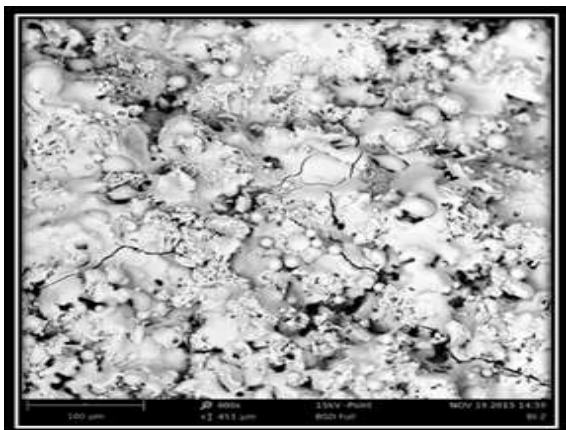
Fig. 6a: The SEM microphotograph of coated dental implant of Ø3.8mm after insertion (x600)

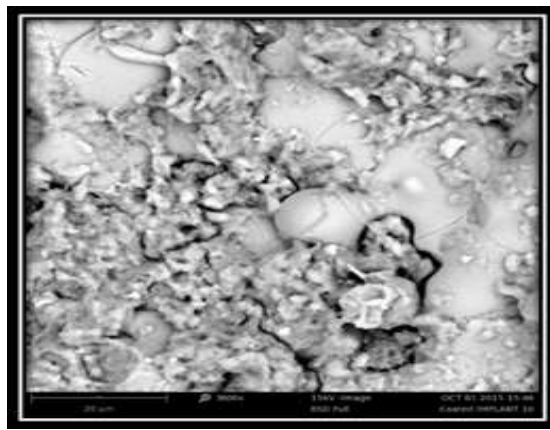
Fig. 7b: The SEM photomicrograph of coated dental implant of 4.2 mm Ø after insertion at higher magnification (x3600)

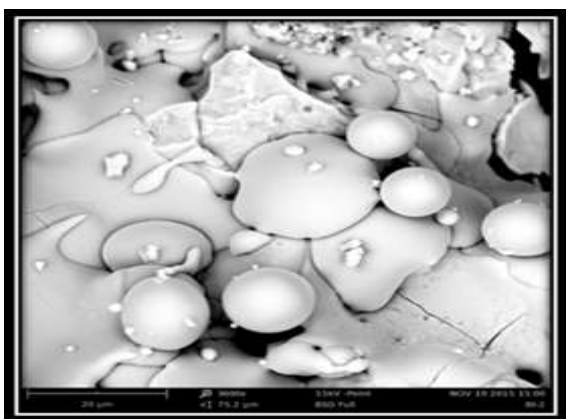
Fig. 6b: The SEM microphotograph of coated dental implant of Ø3.8mm after insertion at higher magnification (x3600)

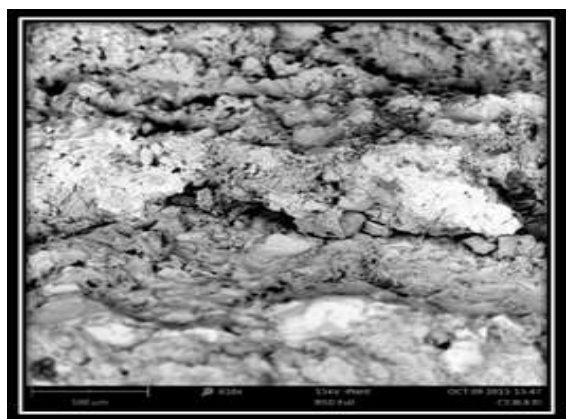
Fig. 7a: The SEM photomicrograph of coated dental implant of 4.2mm Ø after insertion (x600)
